7 January 2008

AgGPS Autopilot System: Fault Code 118

This Support Note describes the causes of the AgGPS® Autopilot™ automated steering system fault code 118: Steering Status Report Packet Not Detected.

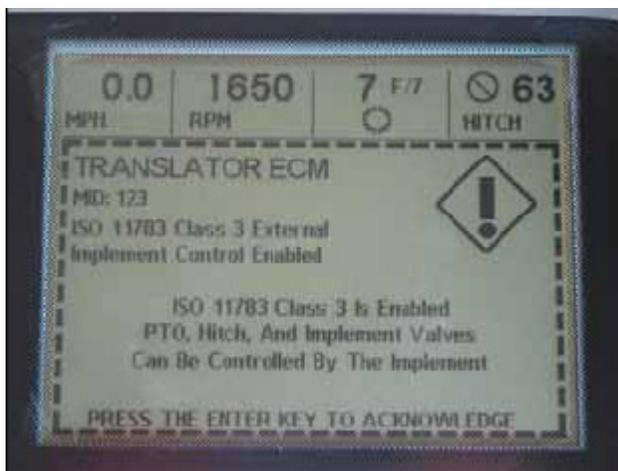
This is a liability warning that automatic control of steering and implement valves will occur. The warning must be acknowledged every time the tractor is started.

1. Turn off the Autopilot system power switch.
2. Start the tractor.
3. Acknowledge the ISO Class 2 enabled message on the armrest console:

4. Turn on the Autopilot system power switch.

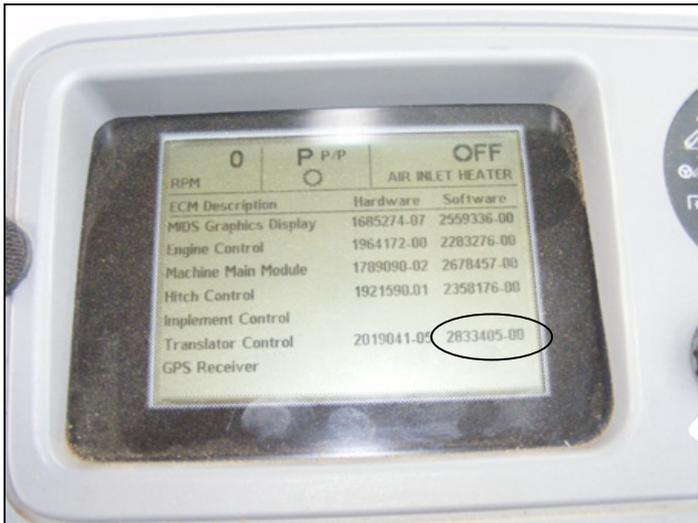
Verify that the vehicle has the correct version of CAN translator installed

1. Turn the upper knob to the hash marks at the 1 o'clock position.
2. Press the Enter key and the right arrow key at the same time. The translator software must be version **283-3405-00** or later:

- If the firmware version is incorrect, a CAT dealer must upgrade the software for Autopilot to operate.

- If this does not appear as an option, a CAT dealer must set “Data Link Translator Module Installation Status” to Installed. This can be done only with the CAT service tool.

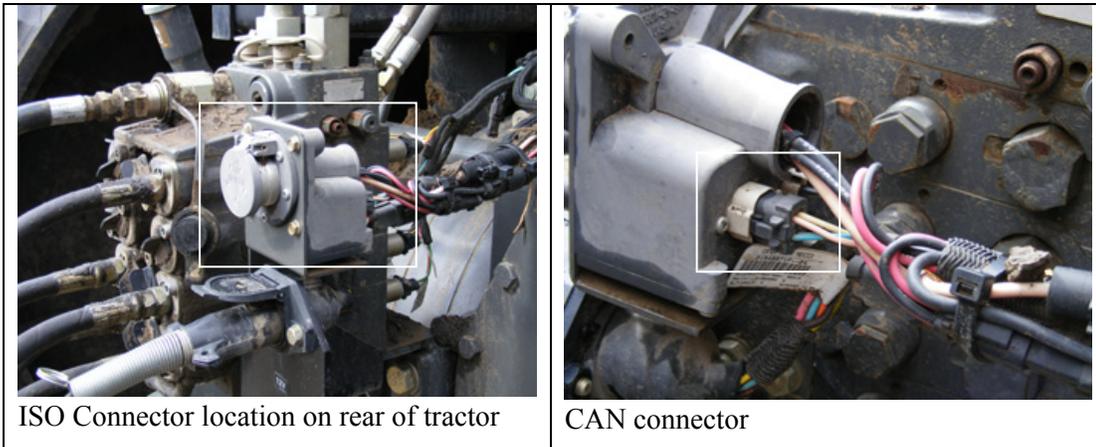
- Check that the ISO connector is installed on the rear of the tractor. On the back of the ISO connector are 2 smaller connectors. One connector is a 4-pin DT-Deutsch connector with yellow, green, red, and black wires.

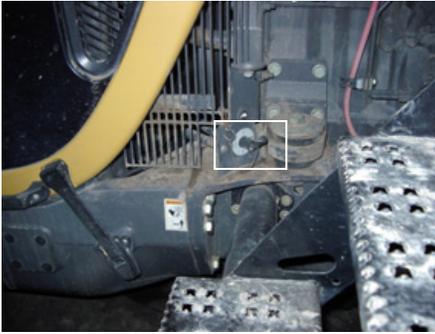
- Check that the grounds on the external harness are correctly connected. Under the right floor board, a harness connects to the tractor. This harness goes to the connector on the rear of the tractor, to chassis ground (unbraided), and cab ground (braided wire).
- Check that both terminators are installed on the external CAN network. They are located:
 - In the connector on the back of the tractor.
 - Under the right side floorboard panel. It is either a 6 or 8-pin Packard connector.
- Check the fuse panel for a loose circuit breaker. The fuse panel is the lower one towards the front of the tractor. Also ensure that the connectors on the outside of the fuse panel are correctly connected.
- Reset the master disconnect switch on the tractor. This is located at the bottom of the operator access stairs.
